City of Bainbridge Island

Traffic Report

2015 Focused Traffic Study

February 9, 2016

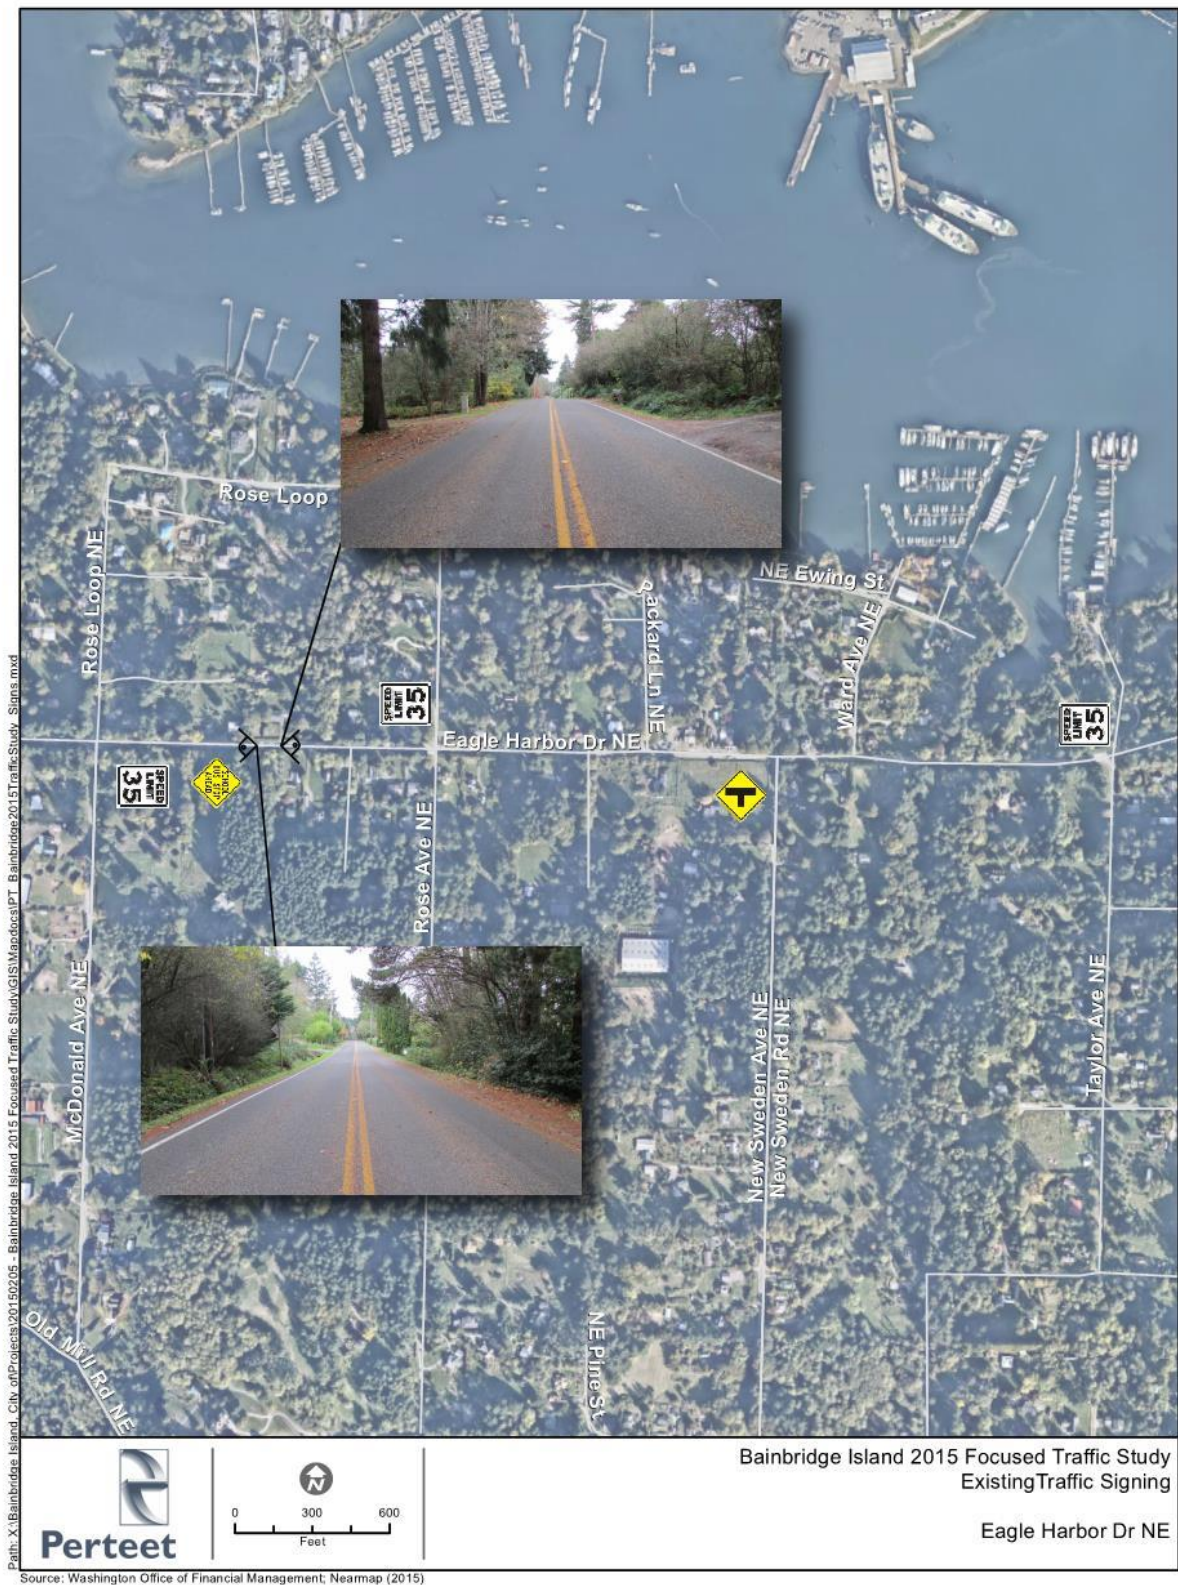
Figure 2-1: Eagle Harbor Drive NE Corridor Map with Signing

Eagle Harbor Drive NE is a minor arterial that connects Wyatt Way NW to Rockaway Beach Road NE, traveling along the southern coast of Eagle Harbor. A horizontal curve in the vicinity of McDonald Avenue NE changes the alignment to run east-west. Eagle Harbor Drive NE has an average daily traffic volume of 1,900 vehicles per day (vpd). The primary objective for this study was to determine whether the existing 35 miles per hour (mph) speed limit on the corridor between McDonald Avenue NE and Taylor Avenue NE is appropriate. Figure 2-1 shows the project limits with the posted regulatory and warning signing along the roadway.

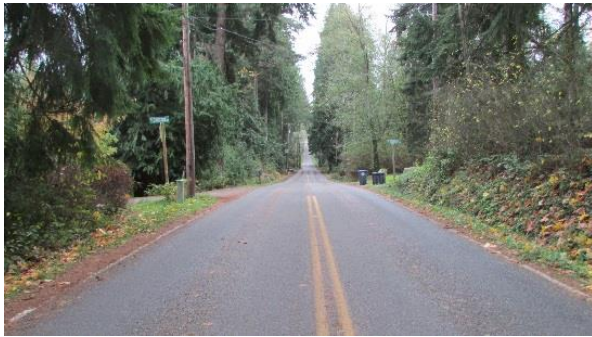
Figure 3-1: Facing South near NE Torvanger Road

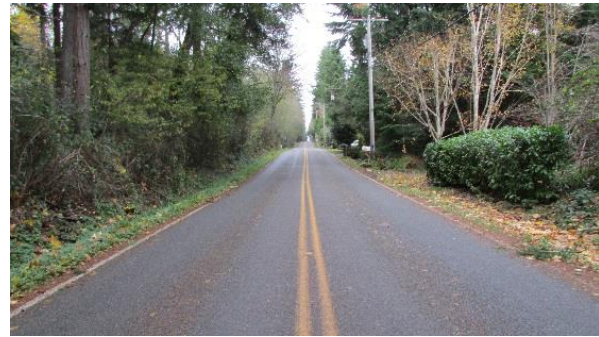
Figure 3-2: Facing North near NE Torvanger Road

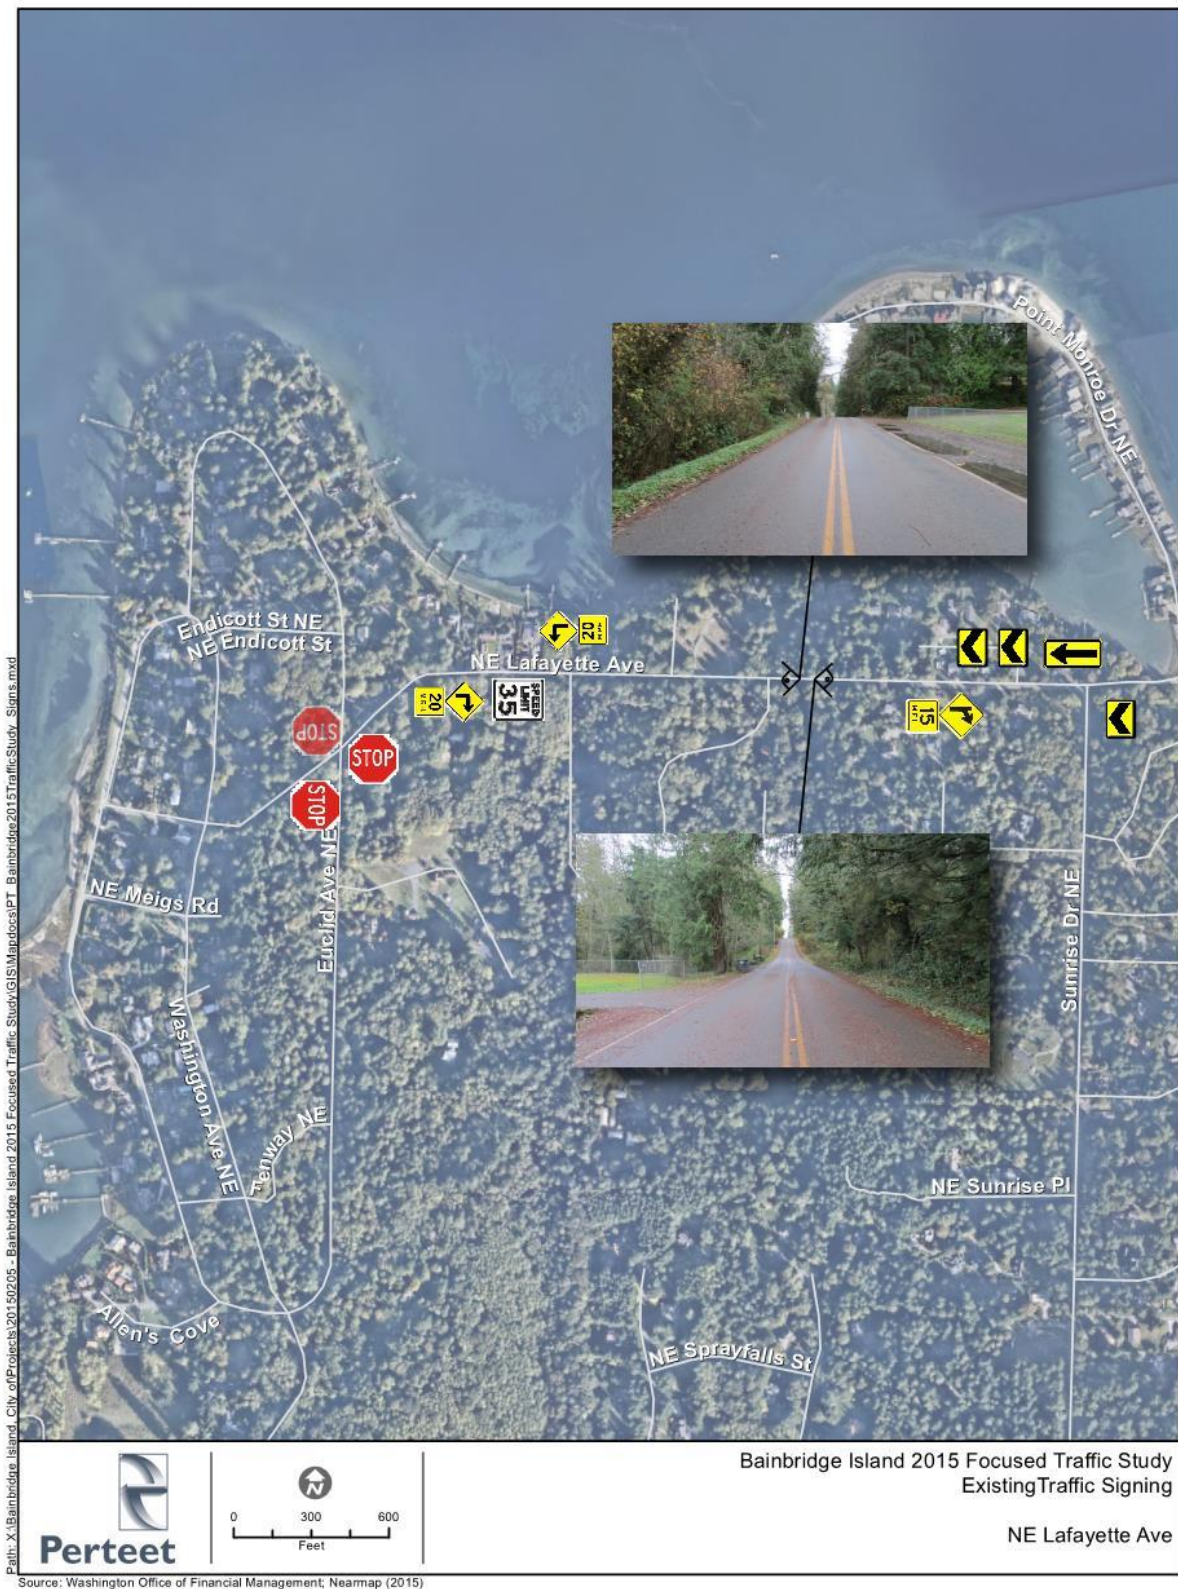
Figure 4-1: NE Lafayette Avenue Corridor Map with Signing

All three collisions occurred where NE Lafayette Avenue turns into NE Sunrise Drive. There are existing turn warning signs, chevrons, and arrow indications of the curve. Additionally, there is an advisory speed sign of 15 mph. From the data, it appears that drivers may be traveling too fast for conditions. Some type of speed reduction would likely reduce the occurrence of these types of collisions.

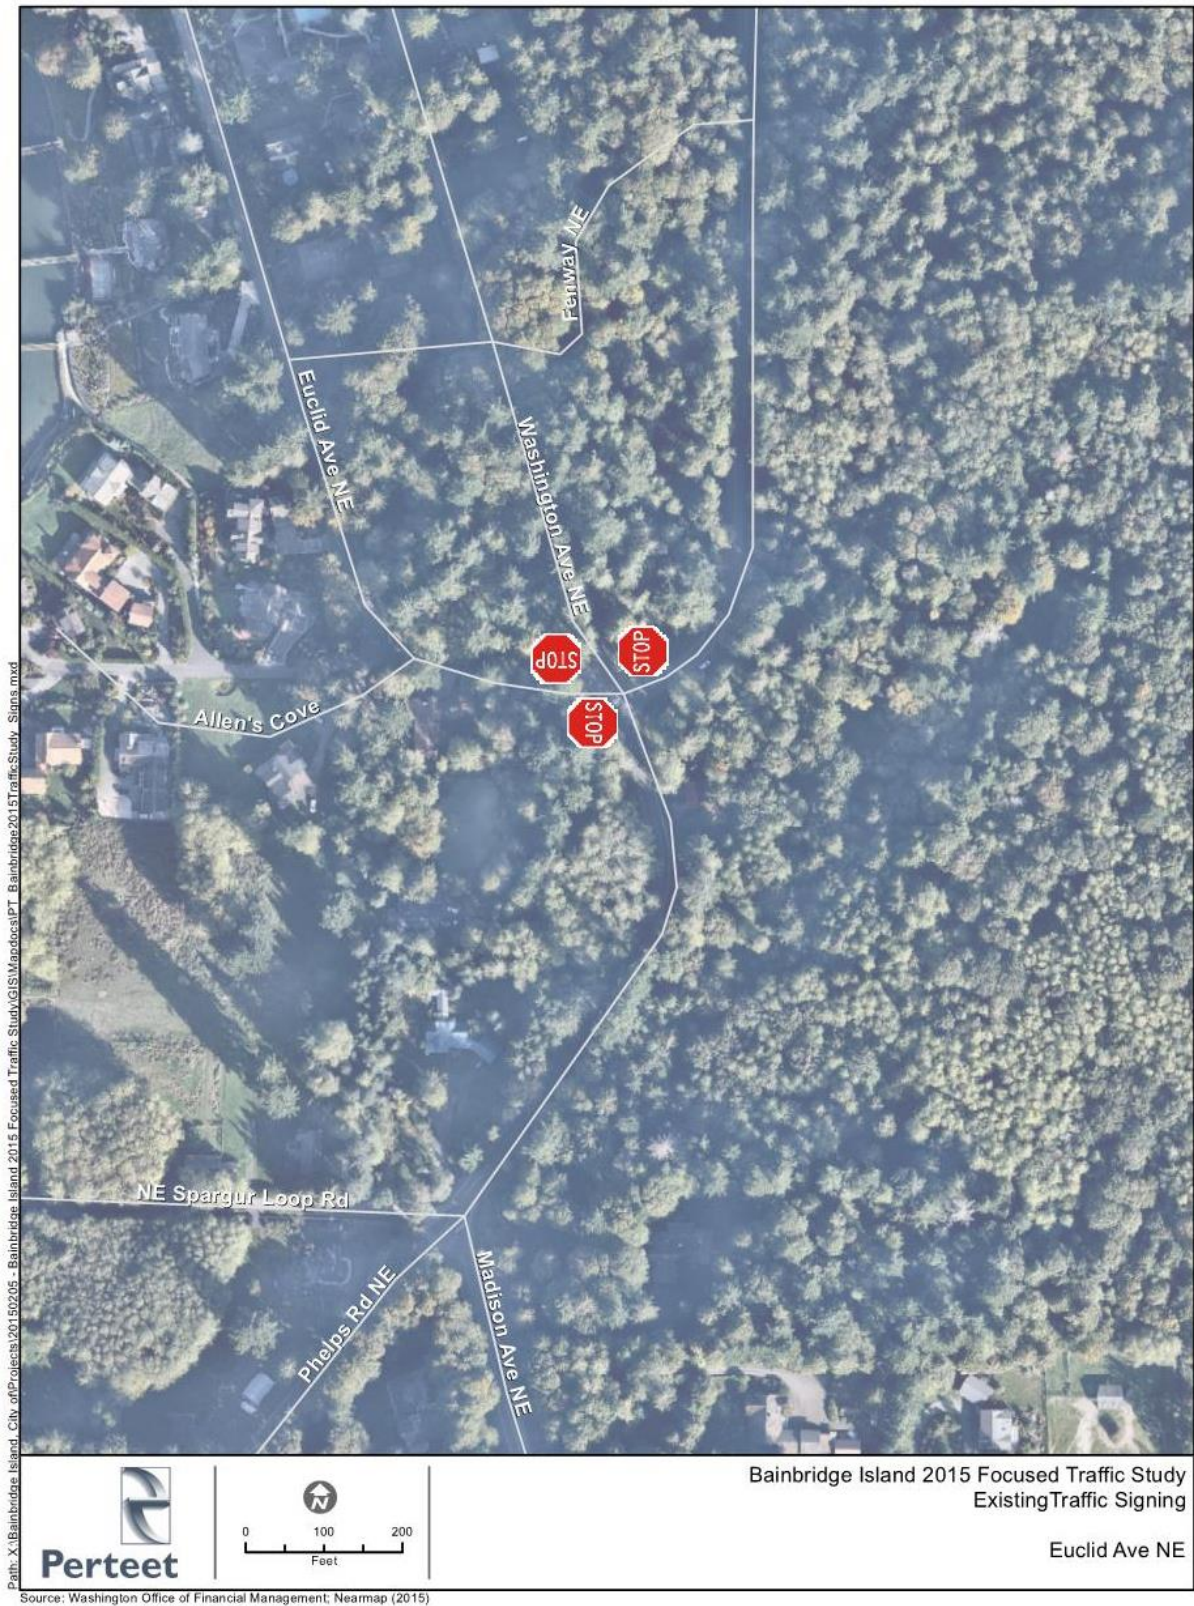
Figure 7-1: Washington Avenue NE and Euclid Avenue NE Intersection Map with Signing

Traffic Control: The traffic control for this intersection meets the MUTCD requirements for stop control. However, having a three-way stop at a four-way intersection is uncommon. For example, stop signs are typically on side streets opposite each other. Due to the predominant movement, this type of approach is not recommended for this intersection. To compensate for potential roadway user confusion, the intersection traffic control should be modified with supplemental signs indicating that northbound traffic does not stop.

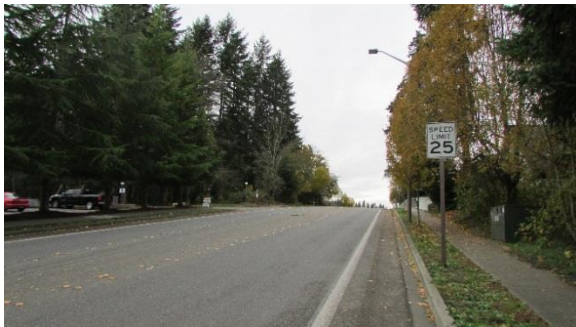
Figure 8-2: Facing West

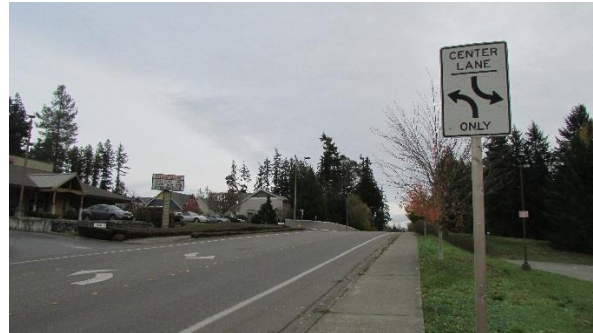
Figure 8-3: Facing East

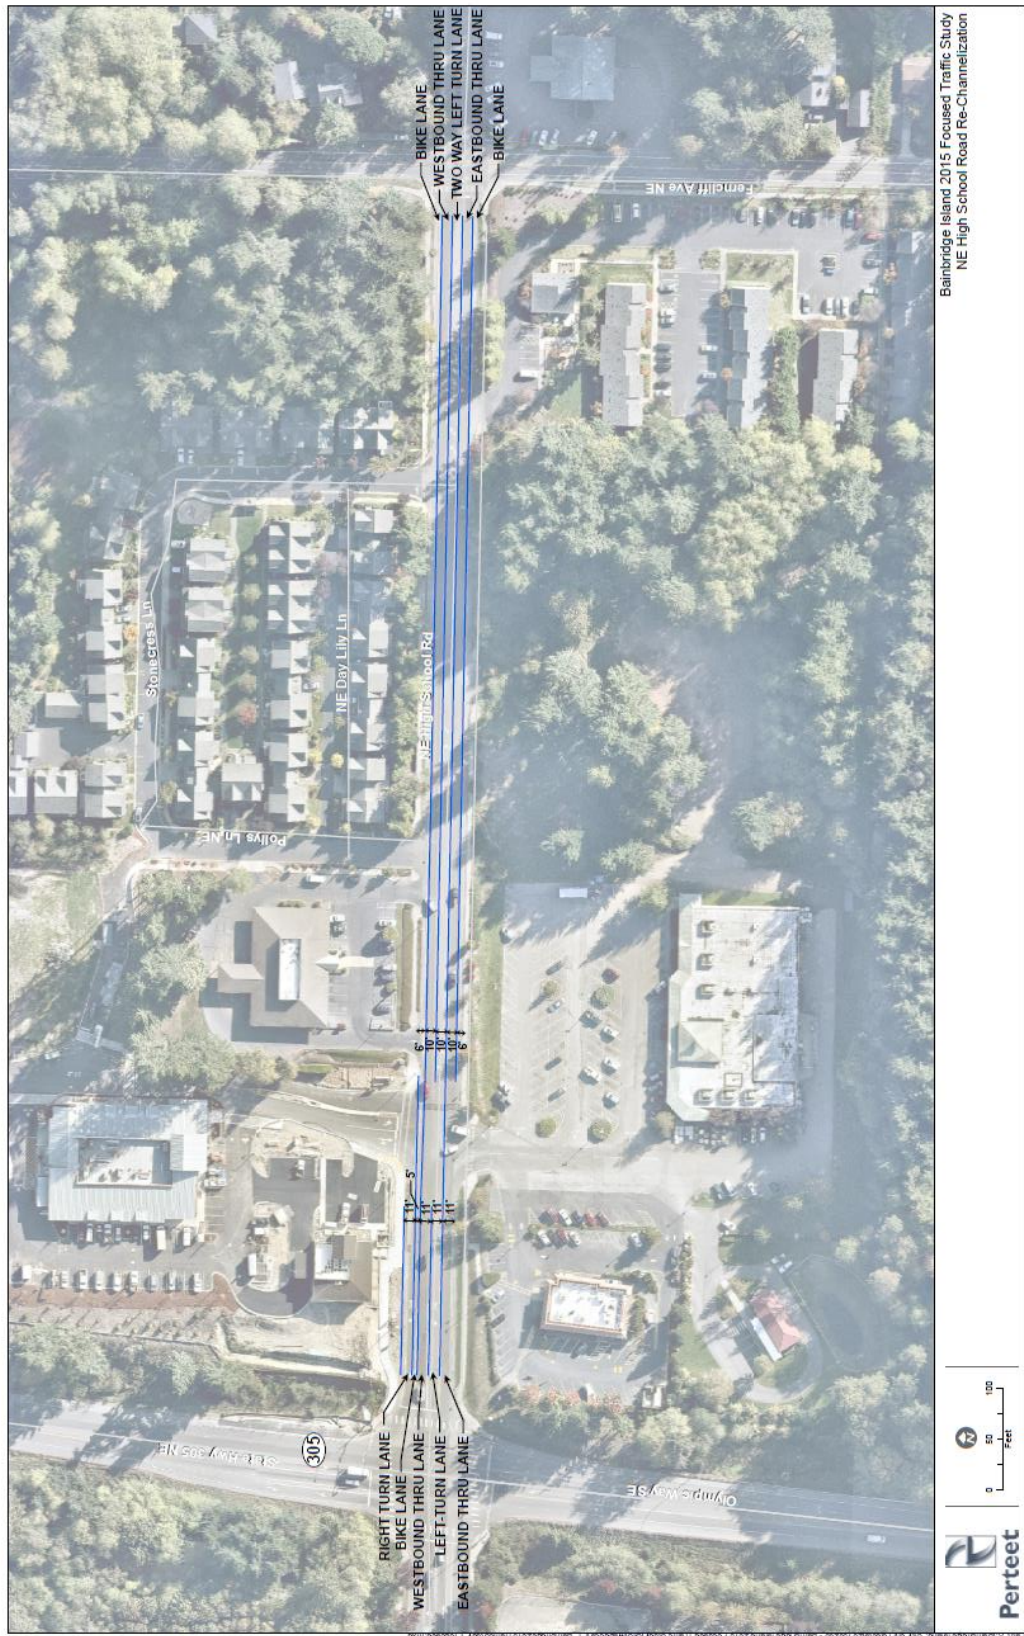
Figure 8-5: Proposed channelization for NE High School Road between SR 305 and Ferncliff Avenue NE

The only recorded serious injury related to a pedestrian or bicycle collision occurred east of SR 305. As noted above, this segment had the highest 85th percentile speed and a higher occurrence of speeding overall. The current channelization should be modified in this segment to improve pedestrian and bicyclist safety. A proposed channelization concept is shown in Figure 8-5. This proposal will increase the bicycle lane to a standard 6-feet and reduce the general purpose traffic lane to 10-feet. By decreasing the width for the general purpose lanes, it is expected that there will be a reduction in the travel speed of vehicles.

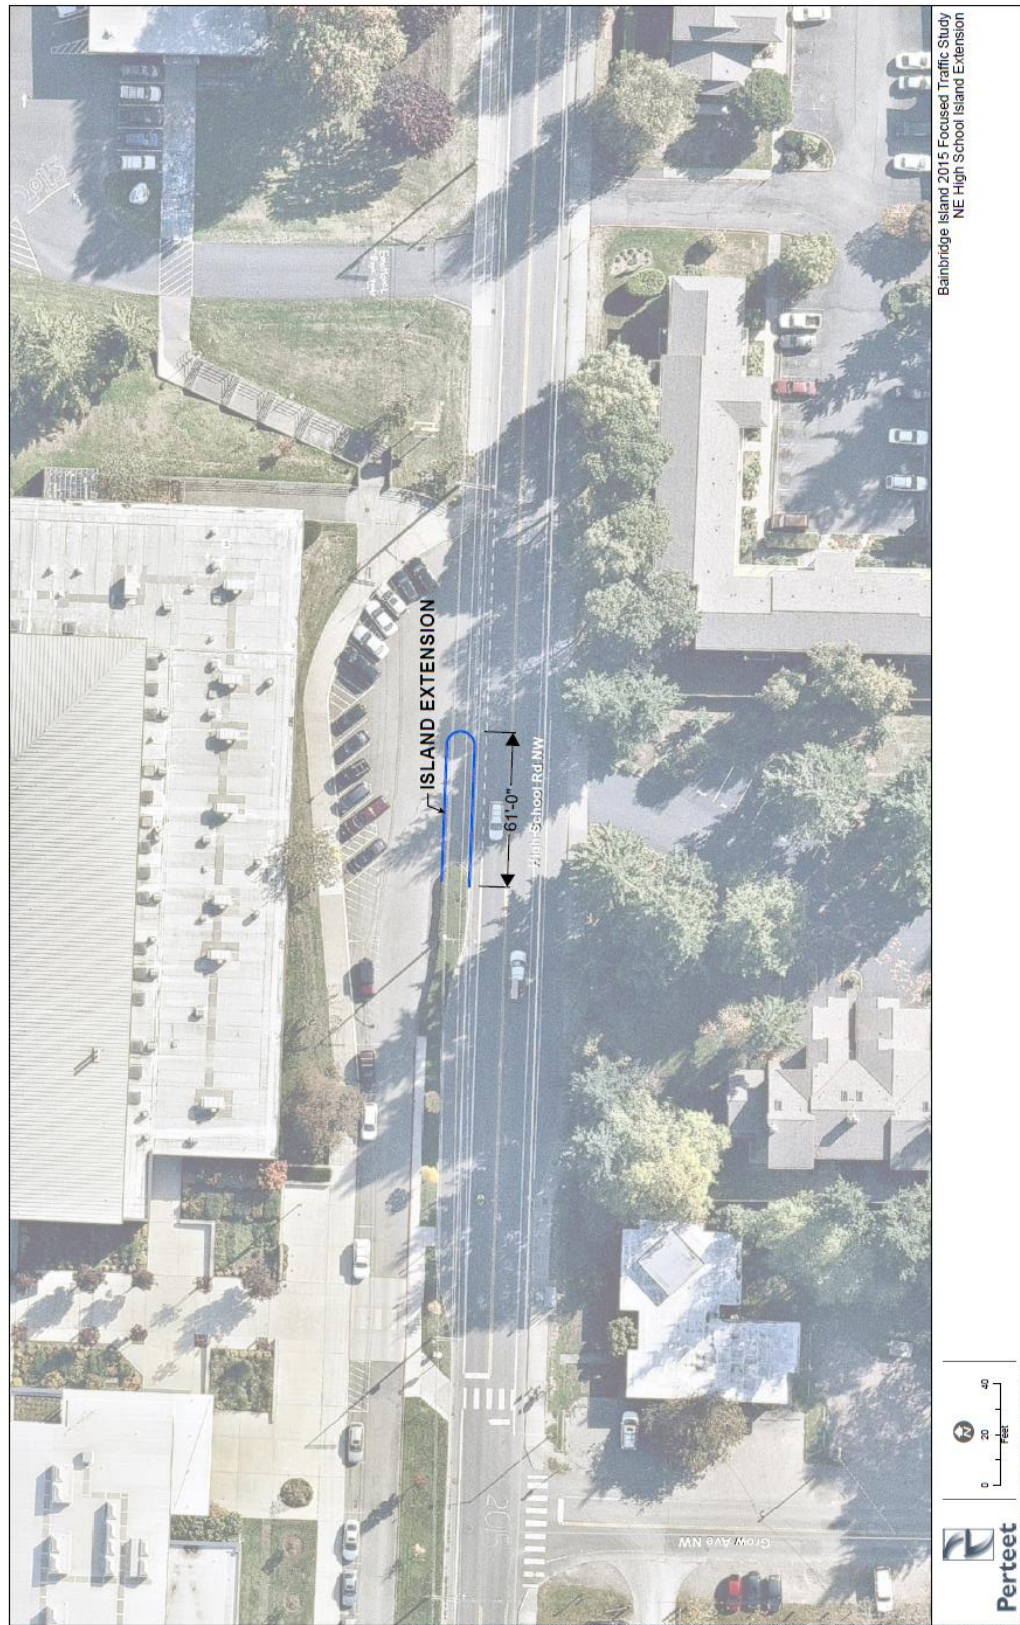
Figure 8-6: Proposed island extension for NE High School Road

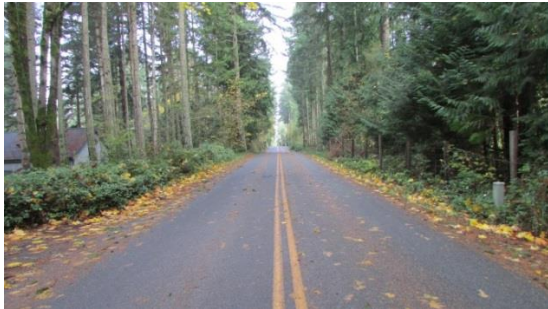
Figure 9-1: Facing North

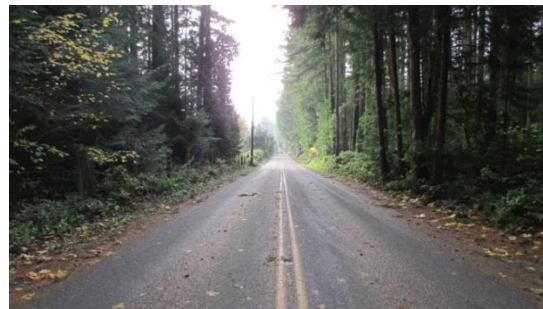
Figure 9-2: Facing South

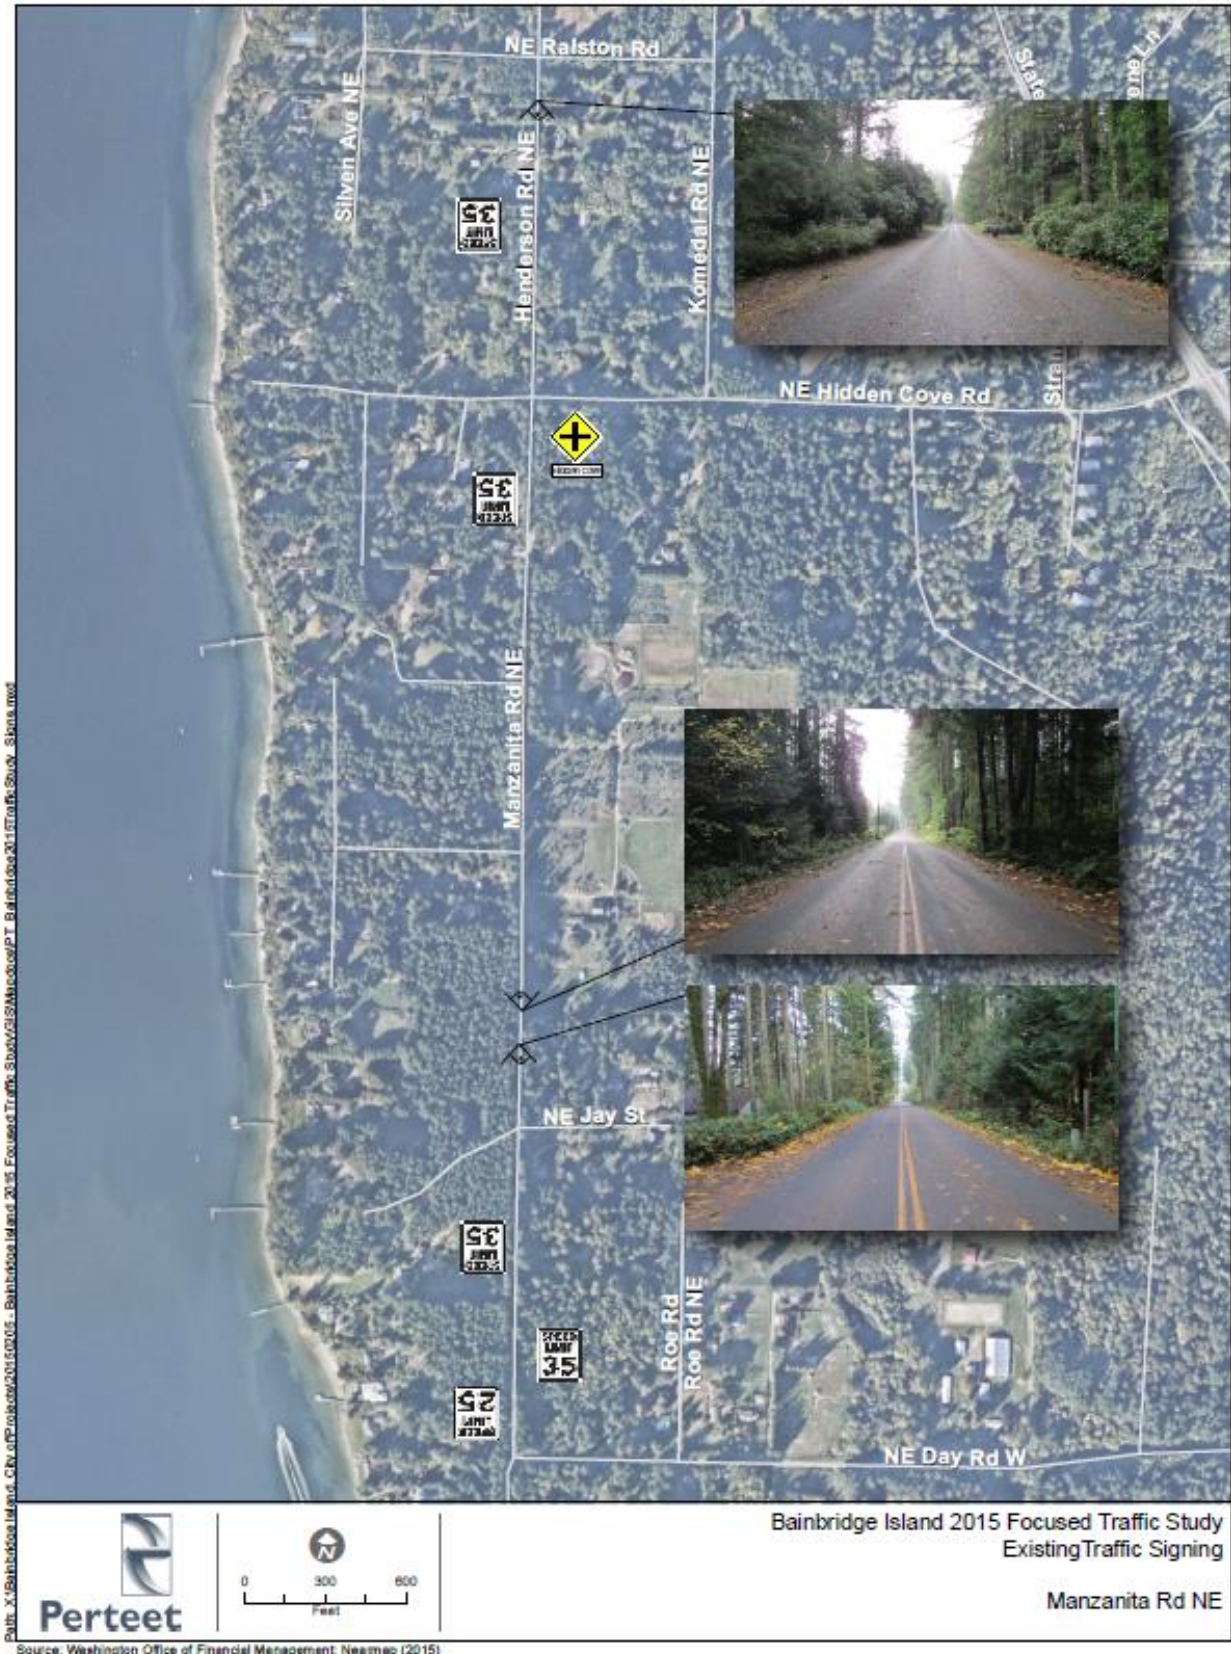
Figure 9-3: Manzanita Road NE Corridor Map with Signing
